# Historic Floors

*Their Care and Conservation*

## **Historic Floors: Their Care and Conservation**

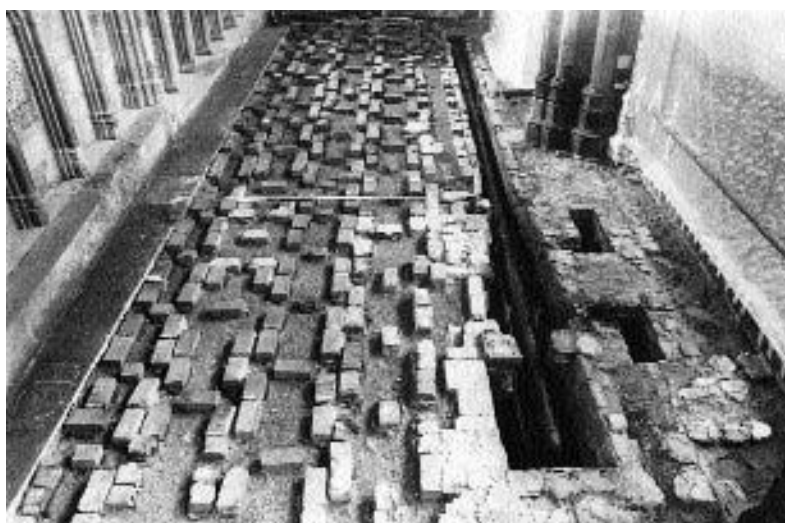
**Figure 2.2** Lichfield Cathedral. Unusual brick sub-structure to support Scott's limestone paving of 1860 in the north choir aisle (Photograph, Warwick Rodwell)

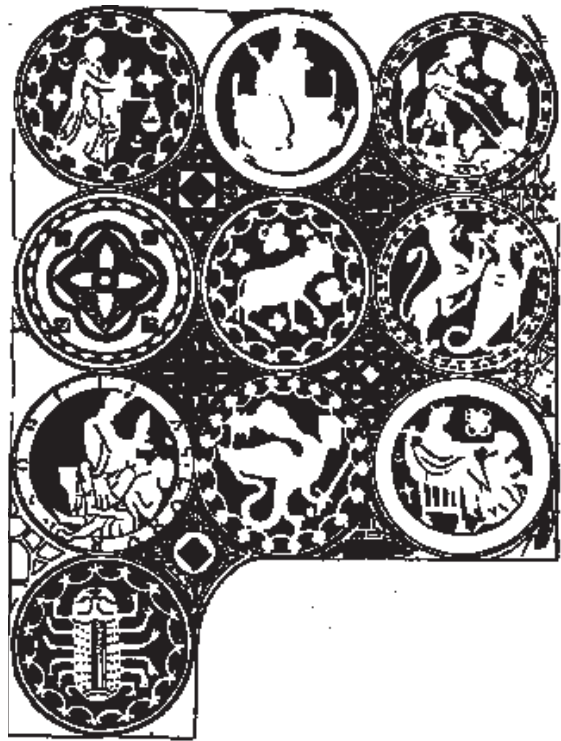
**Figure 3.2** Canterbury Cathedral. Roundels from the *Opus Alexandrinum* pavement. The drawing shows the amount of wear on the tile, and was made in c. 1858.

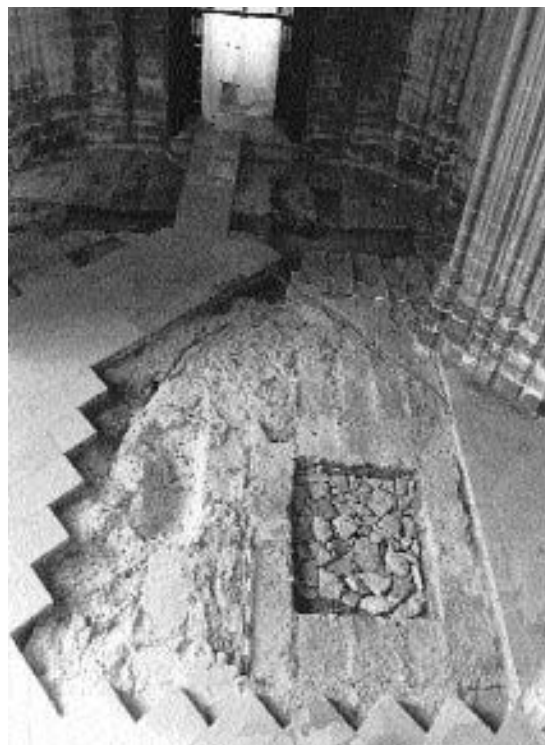
**Figure 4.2** Norman floor-bedding mortar at the west end of the nave. Note the broken Norman floor slabs in the backfilled grave (removed during the 1787 reflooring), and the pattern of the 1787 floor slabs (scales 2 m) (Photograph, Canterbury Archaeological Trust)

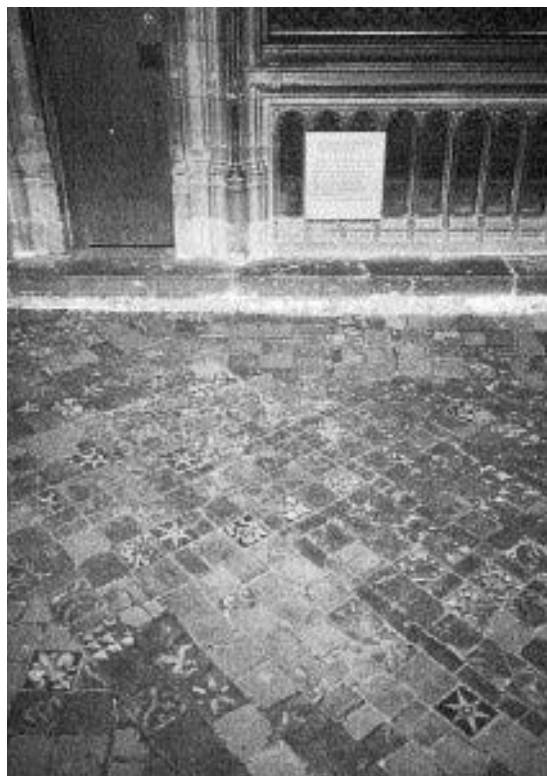
**Figure 12.2** Conserved tiles, many of which are in situ, completed in the first stage of work. Isolated replica tiles are visible (Photograph, Peter Bird)
